OCAMA AIRMUNITIONS LETTER
NO. 136-11-56C

SUMMARY OF NUCLEAR WEAPONS INCIDENTS (AF FORM 1058) AND RELATED PROBLEMS JUNE 1960

2. This summary includes the incident at McGuire AFB, New Jersey, on 7 June 1960. This incident will hereafter be referred to as NWI-60-1.

SUBJECT: Report of Special Weapons Incident [REDACTED], Bomarc Site, McGuire AFB,
New Jersey

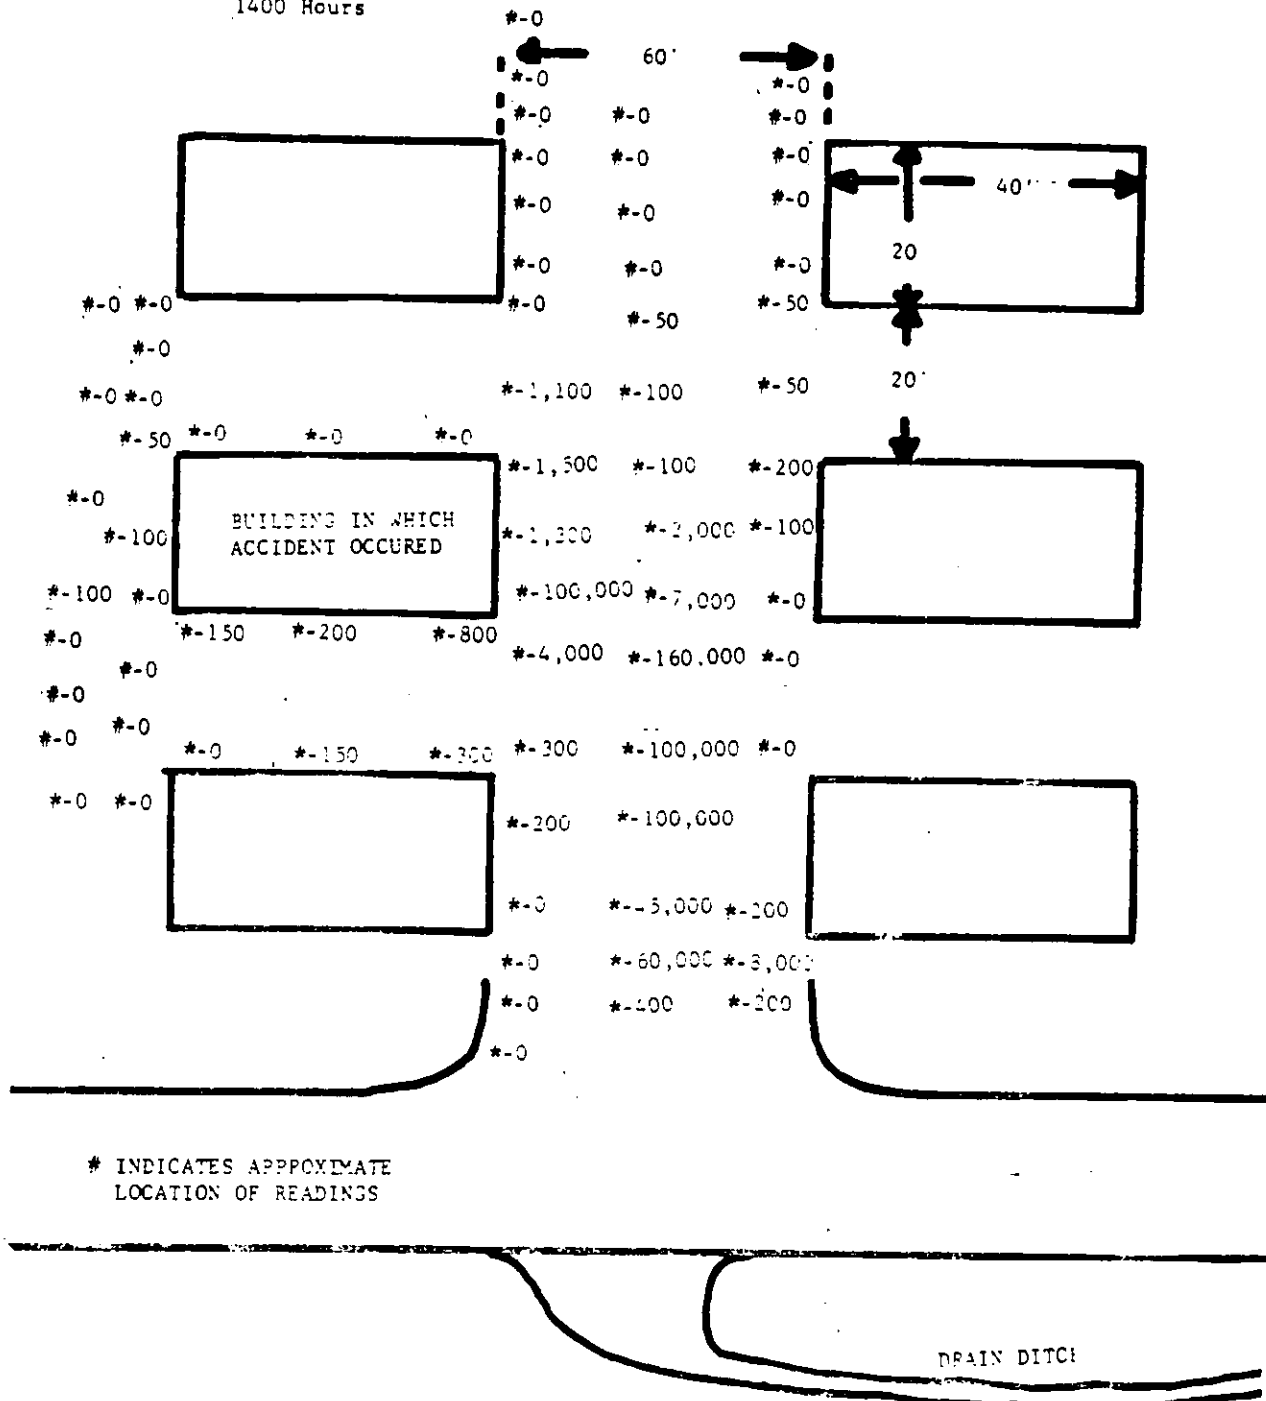
FIGURE 1. Monitoring Survey Results, 8 June 1960.

(4) EOD personnel returned to the area on 8 June 1960. The area was allowed to dry and Staplex Air Samplers were erected. (Later reading of the filter papers indicated a reading of 1.59 DPM.) At 1000 hours (EDST) monitoring outside of the shelter disclosed a high reading of 160,000 CPM. (It was evident that contamination found outside of the shelter was deposited by the sluicing of the shelter with water.) Public Health Service Officers conducted an off-base survey of

approximately 66 square miles and reported that no contamination were found. Another survey was made inside the shelter it had dried. A reading of over 2,000,000 CPM was taken near the warhead residue. Other areas within the shelter had 100 CPM to 50,000 CPM. The entire inside of the shelter and all readings indicating contamination were limited immediately around and slightly forward of the warhead area was roped off and kept wet the rest of the day June. Personnel entering the area were kept to a minimum. An accident investigation team trying to determine the cause of explosion and fire. (Reference Figure 1.)
