NPIC/R-1585/63 December 1963

NEW SURFACE-TO-AIR MISSILE, MOSCOW PARADE 7 NOVEMBER 1963

NATIONAL PHOTOGRAPHIC INTERPRETATION CENTER

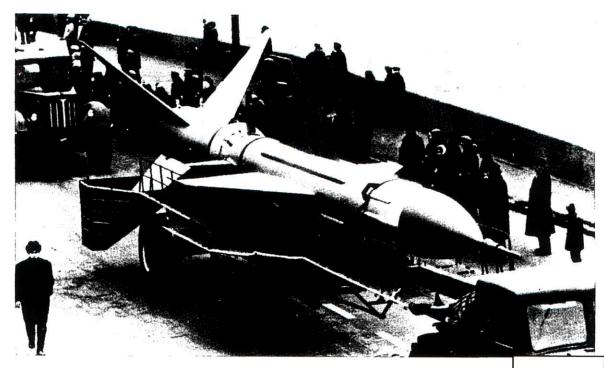
FIGURE 1. MISSILE ON TRAILER.

7 November 1963 revealed four surface-to-air missiles reported by the Soviets to be antimissile missiles. The numerical designations 1240738, 1245211, and 1245215 are visible on three of the missiles; the designation of the fourth missile was not observed. The missiles are two-stage surface-to-air missiles on spe-

cially designed trailers towed by what are probably tractor versions of the MAZ 502 cargo truck (Figures 1 and 2). Each missile consists of a booster and a combination sustainer and warhead stage, with an overall length of feet from the tip of the pressure probe to the rear of the booster nozzle. The overall length of the tractor-trailer is feet.

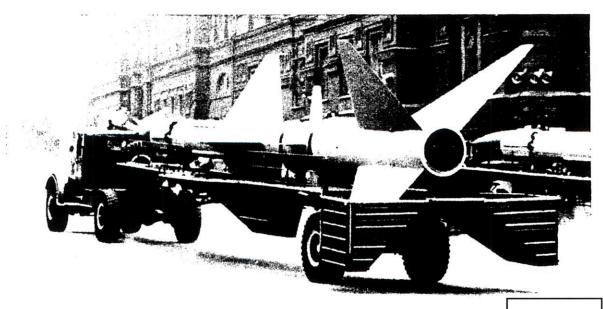
FIGURE 2. MISSILE AND TRACTOR-TRAILER.

The tractor-trailer used for the missile has an overall length of _____ feet; the missile trailer measures _____ feet in length and _____ feet wide. The dimensions of the unloaded trailer are probably different, as evidenced by the fold-down catwalks protecting the sustainer

stabilizer fins. In such instances, the trailer dimensions would probably decrease in width. The trailer does not have a launch or erector capability and its design (one vertical booster stabilizer fin extends through the trailer carriage into a boot) necessitates a lifting device for removal of the missile from the trailer. The missile is supported by four and a suspect fifth cradle, at least one of which appears to be hand-cranked to the level of the missile. The missile is secured to the trailer by three tie-

down bands. One band, which is probably tightened by means of a wheel handcrank attached to the cradle support, is located on the forward end of the booster stage; the second is on the aft portion of the sustainer; and the third is on the forward section of the sustainer feet aft of the warhead. The third tie-down band has raised channels that permit passage of the external cableways.

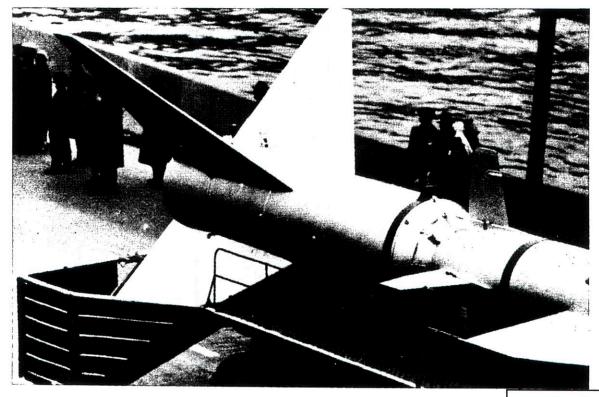
FIGURE 3. BOOSTER STAGE.

25X1D bilizer fins. The booster stabilizer fins are opposed on axes of 45 degrees to the sustainer control and stabilizer fins. The booster is divided into a nozzle section feet long and feet in diameter, and a ranging from in diameter motor case that mates with the sustainer nozzle skirt. Positioned on opposite sides of the missile forward of the booster stabilizer fins are two plugs, possibly cable connections. Located on the top and to the rear of the booster are two probable handling/hold-down couplings. No details on the booster nozzle can be furnished because of the cover plug. The sustainer and warhead stage (Figures The booster stage (Figure 3) has an overall 4 and 5) measures in length from the length of feet and a diameter of feet. tip of the pressure probe to the edge of the sustainer nozzle skirt. The sustainer, excluding the

25X1D The diameter of the booster, including the length of each stabilizer fin, is feet. The four 25X1D stabilizer fins are positioned on axes of 90 degrees at the rear of the booster, and each has 25X1D a surface area of square feet. No control or trim tabs were observed on the booster sta-

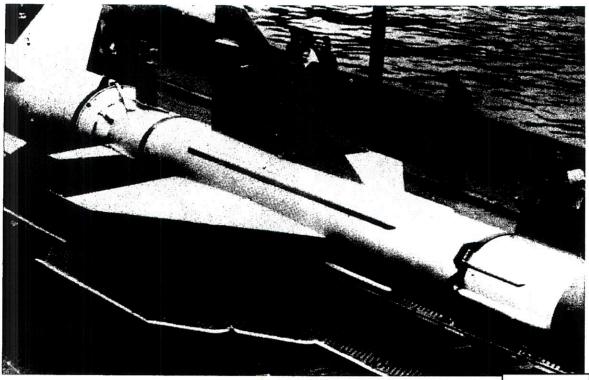
FIGURE 4. SUSTAINER AND PORTIONS OF BOOSTER AND WARHEAD.

square feet, which pivot on control-fin shafts				
	protruding from the sustainer. The diameter of				
25X1D	the sustainer, including the length of the control				
	fins, is feet. Located forward of the control				
	fins are four stabilizer fins positioned on axes				
25X1D	of 90 degrees, each with a surface area of				
	square feet. On at least one, and probably two,				
25X1D	of the stabilizer fins are trim tabs with a con-				
	trol surface of square feet. Another un-				
	identified appendage is observed forward of the				
	trim tab. The overall diameter of the sustainer,				
25X1D	including the length of the stabilizer fin, is

•	feet. Located at the tip of each visible stabilizer				
25X1D	fin is an antenna feet in length. It should be				
	noted that the stabilizer antenna was missing				
	on one of the missiles. In addition, two probable				
	stabilizers feet in length are positioned on

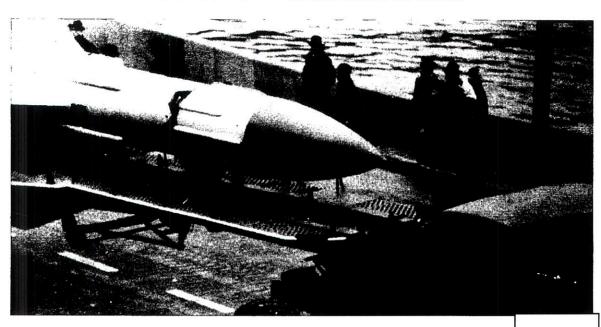
FIGURE 5. WARHEAD AND PORTION OF SUSTAINER.

an axis of 180 degrees at the front of the sustainer aft of the warhead section. External cableways of various lengths are visible on both sides of the sustainer. One external cableway connects the booster and sustainer stages. The warhead section of the missile (dark-toned area) measures feet in length. The curvature of the ogive cannot be determined accurately from available photography. The pressure probe measures feet in length, with a maximum diameter of and a minimum of
